MISCELLANEOUS PAPER NO. 4-852

# EVALUATION OF HARVEY TWO-PIECE LANDING MAT (AM2)

November 1966

U. S. Army Engineer Waterways Experiment Station  
CORPS OF ENGINEERS  
Vicksburg, Mississippi

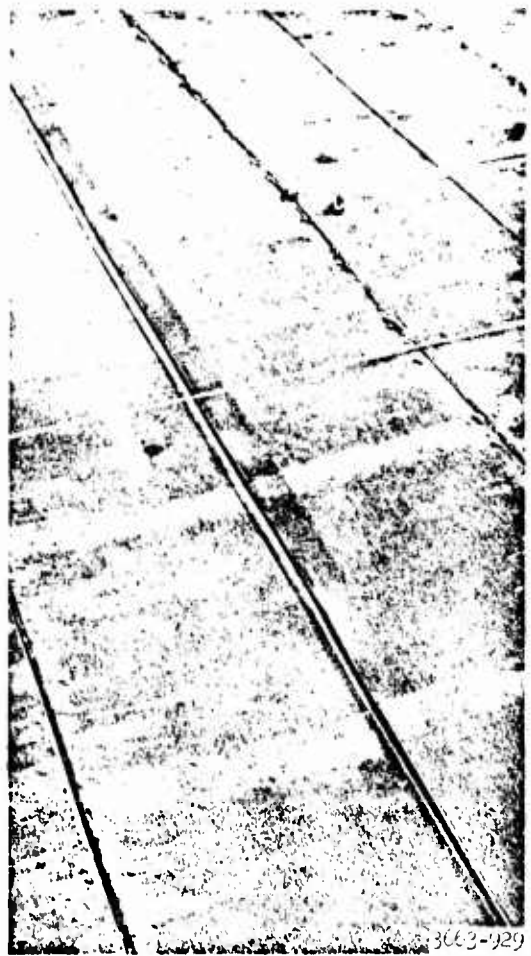
23. By the time 70 coverages of traffic had been completed, three additional planks had failed in test item 1, making a total of 6 failed planks or 20 percent of the planks undergoing tests. Two of these failures were end-joint failures similar to that shown in fig. 3. The other was a longitudinal weld failure as shown in fig. 4. A general view of test item 1 after 70 coverages is shown in photograph 3. Since 20 percent of

Fig. 4. Lane 1, item 1, longitudinal weld failure after 70 coverages

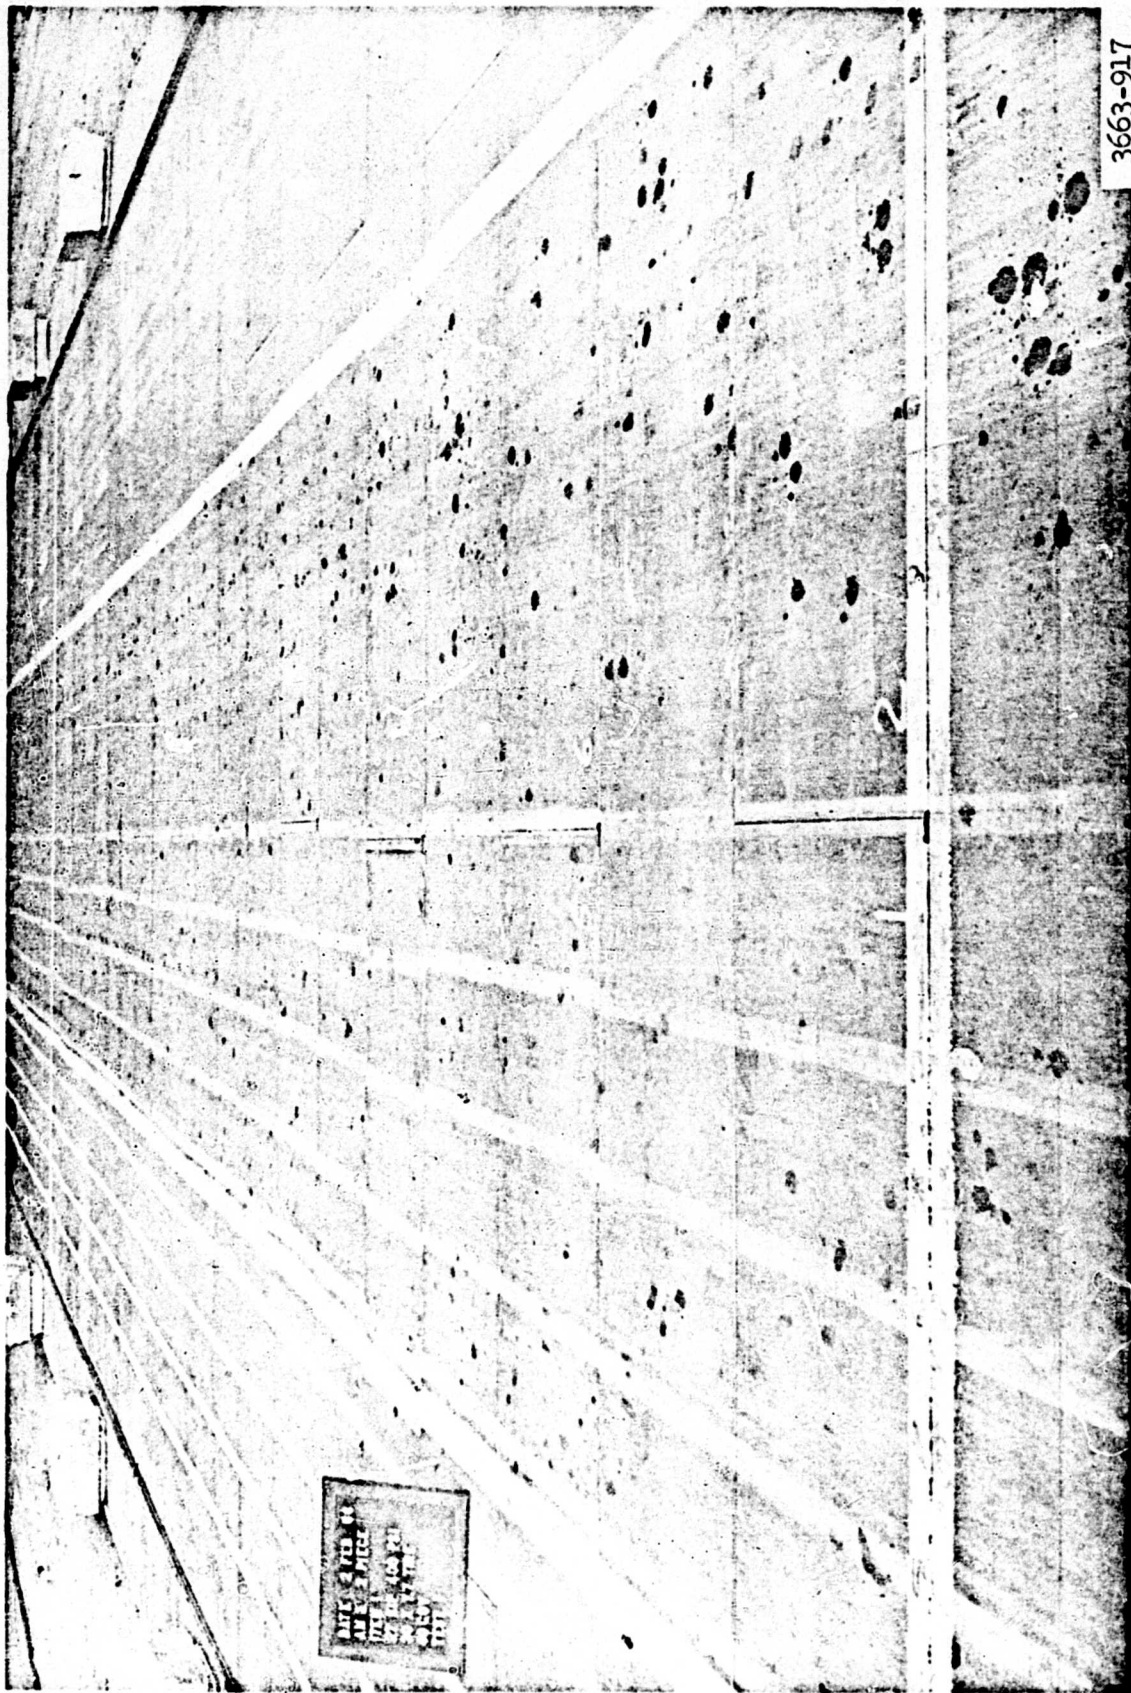
21. Visual observations. A general view of the test lane prior to traffic is shown in photograph 1. The first defect to show up in the mat was a hairline crack in the weld of an underlapping end connector strip on one plank in test item 3. This crack was noted after two coverages. After 14 coverages, several small weld cracks were noted at the corner of the end connector strips on several planks in test item 1. These

Photograph 2. Lane 1, item 1, after 40 coverages

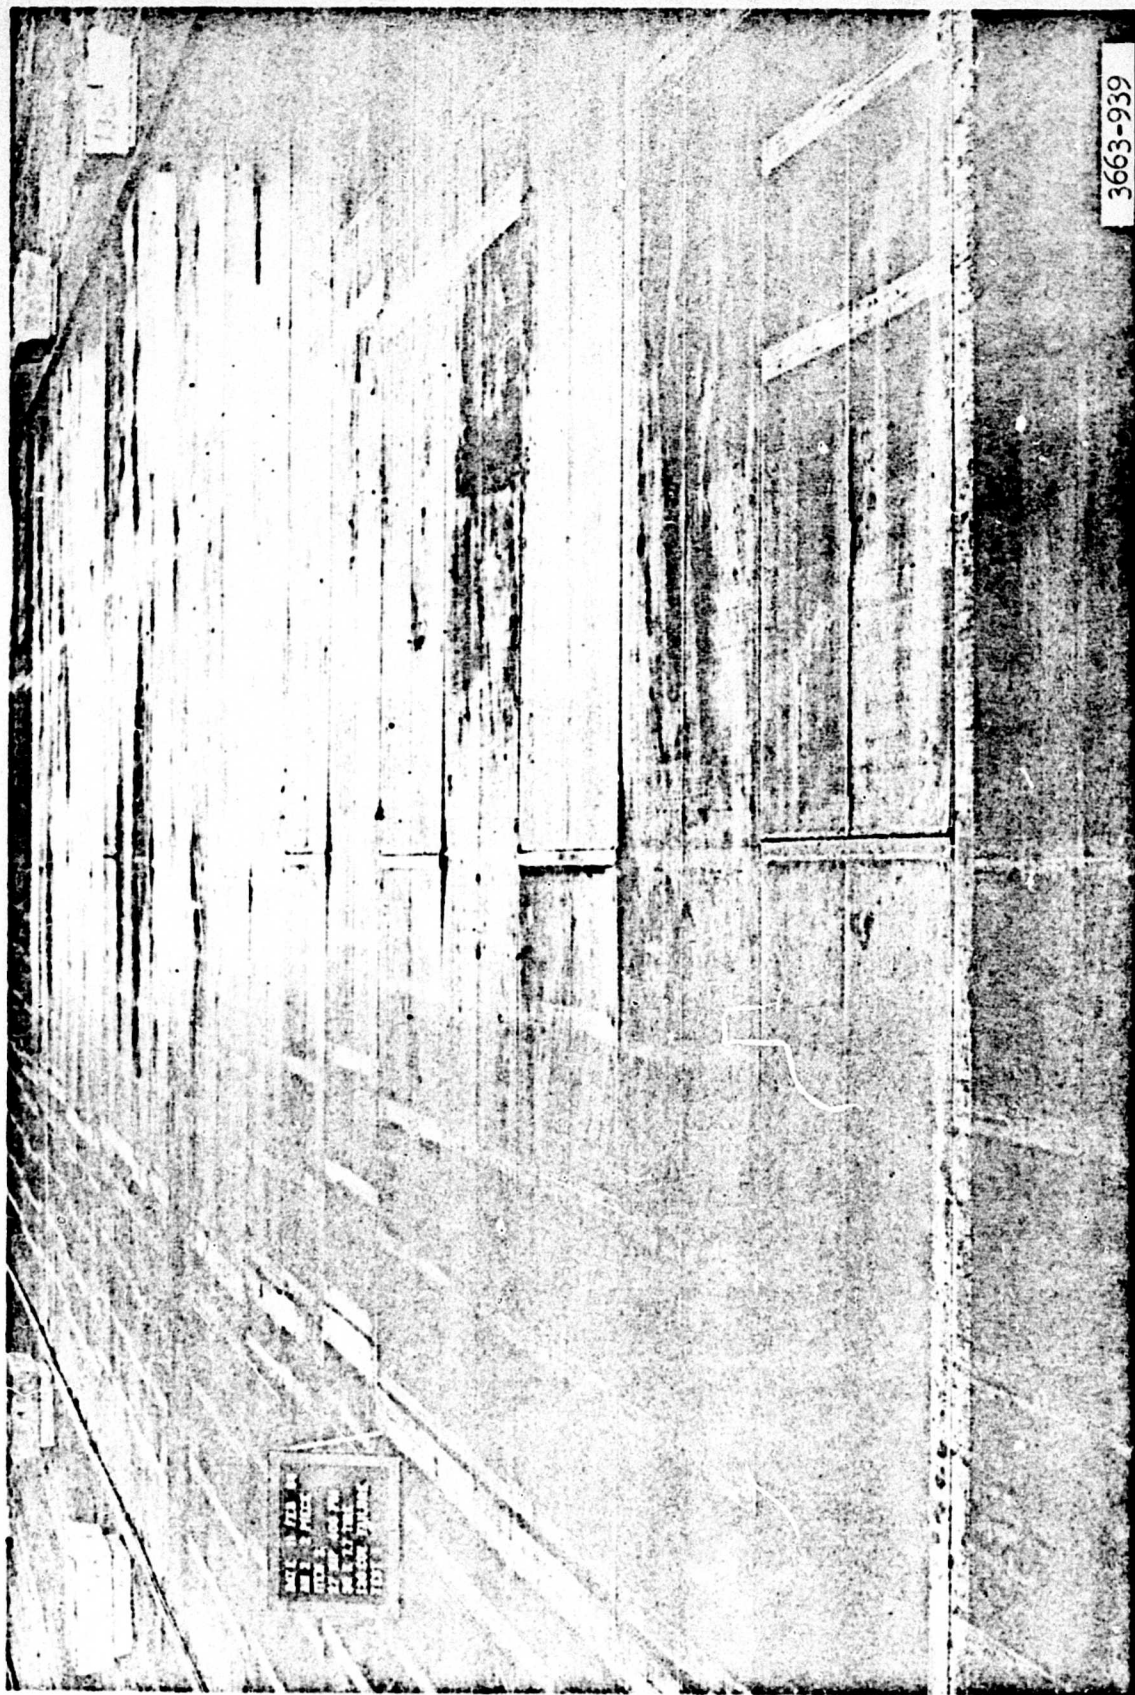
view of test item 2 at the end of 130 coverages is shown in photograph 4. All of the failures in item 2 were of the same type; the weld between the end connector strip and the body of the plank failed, allowing the end connector to separate from the plank.

Photograph 4. Lane 1, item 2, at failure after 130 coverages

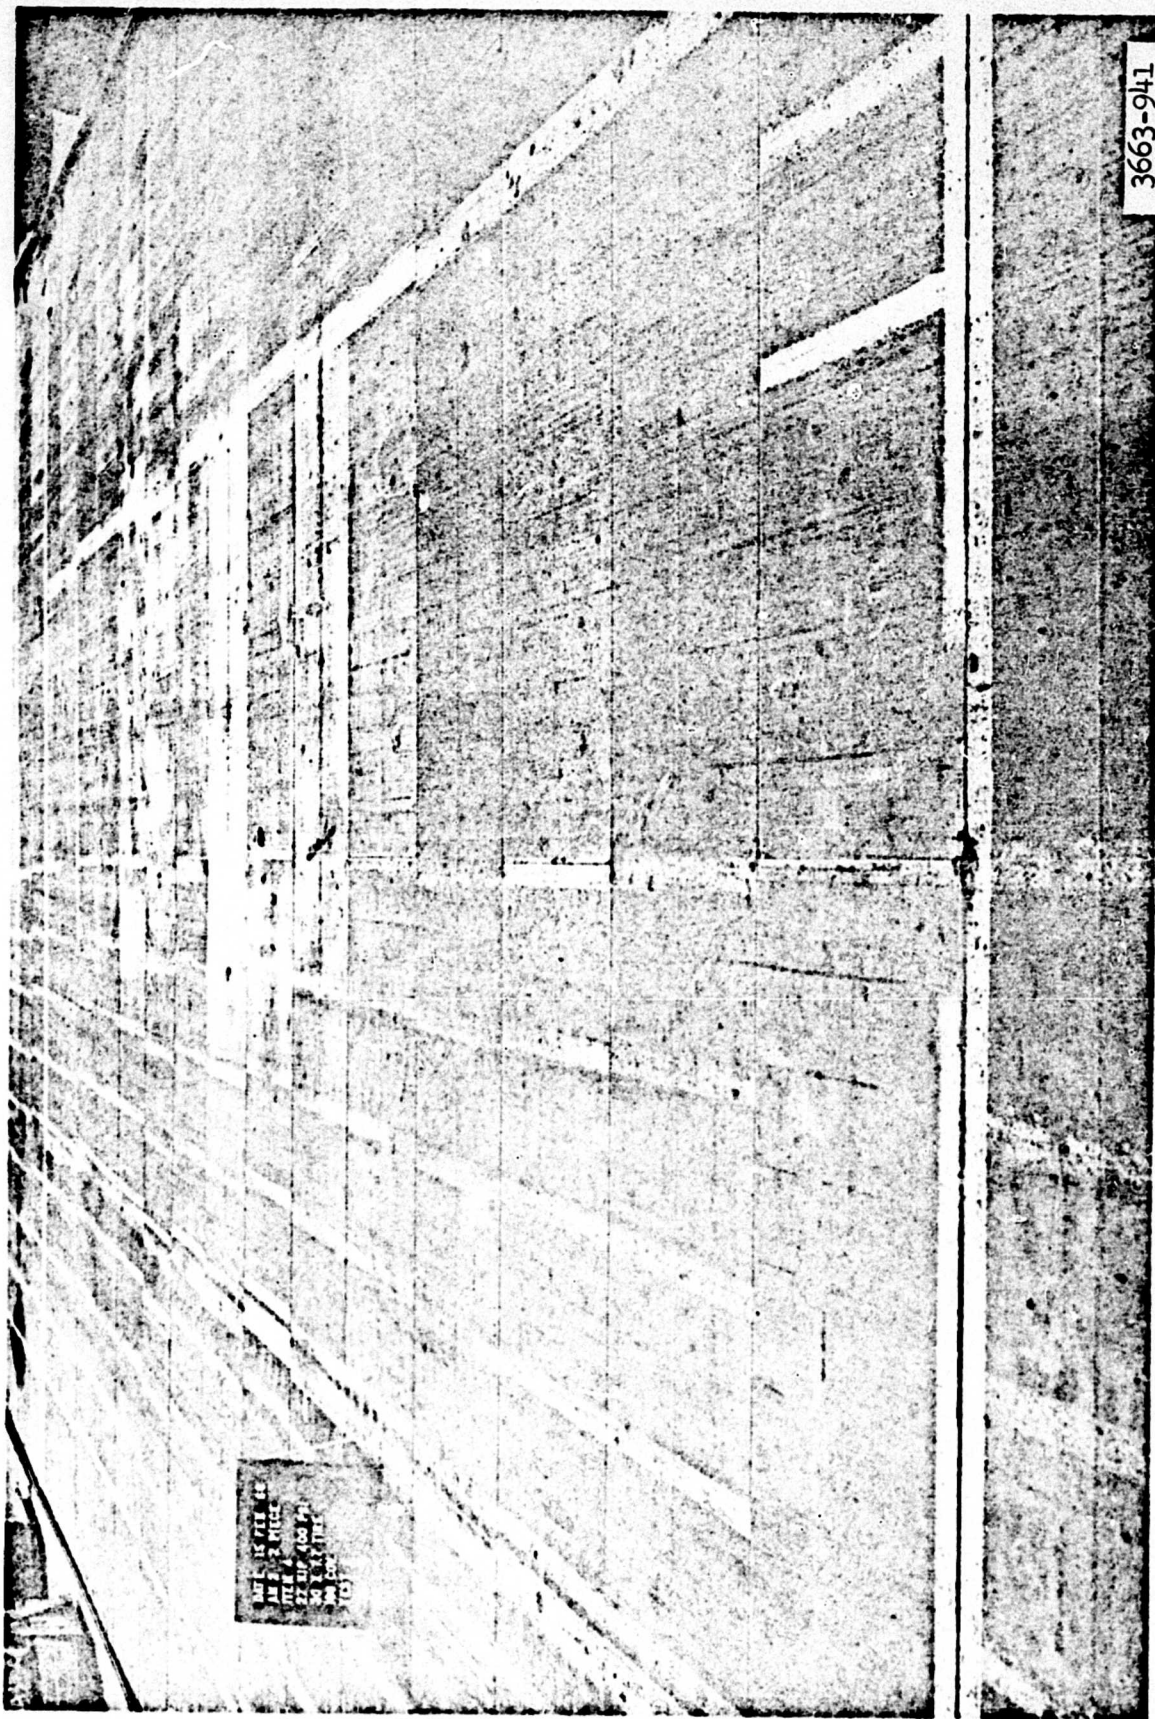
25. The mat in test items 3 and 4 was in good condition after 130 coverages except for one end connector joint failure in item 3. Traffic was continued for the full 188 coverages on these two items with no further failures developing. General views of items 3 and 4 after 188 coverages are shown in photographs 5 and 6, respectively.

Photograph 6. Lane 1, item 4, after 188 coverages

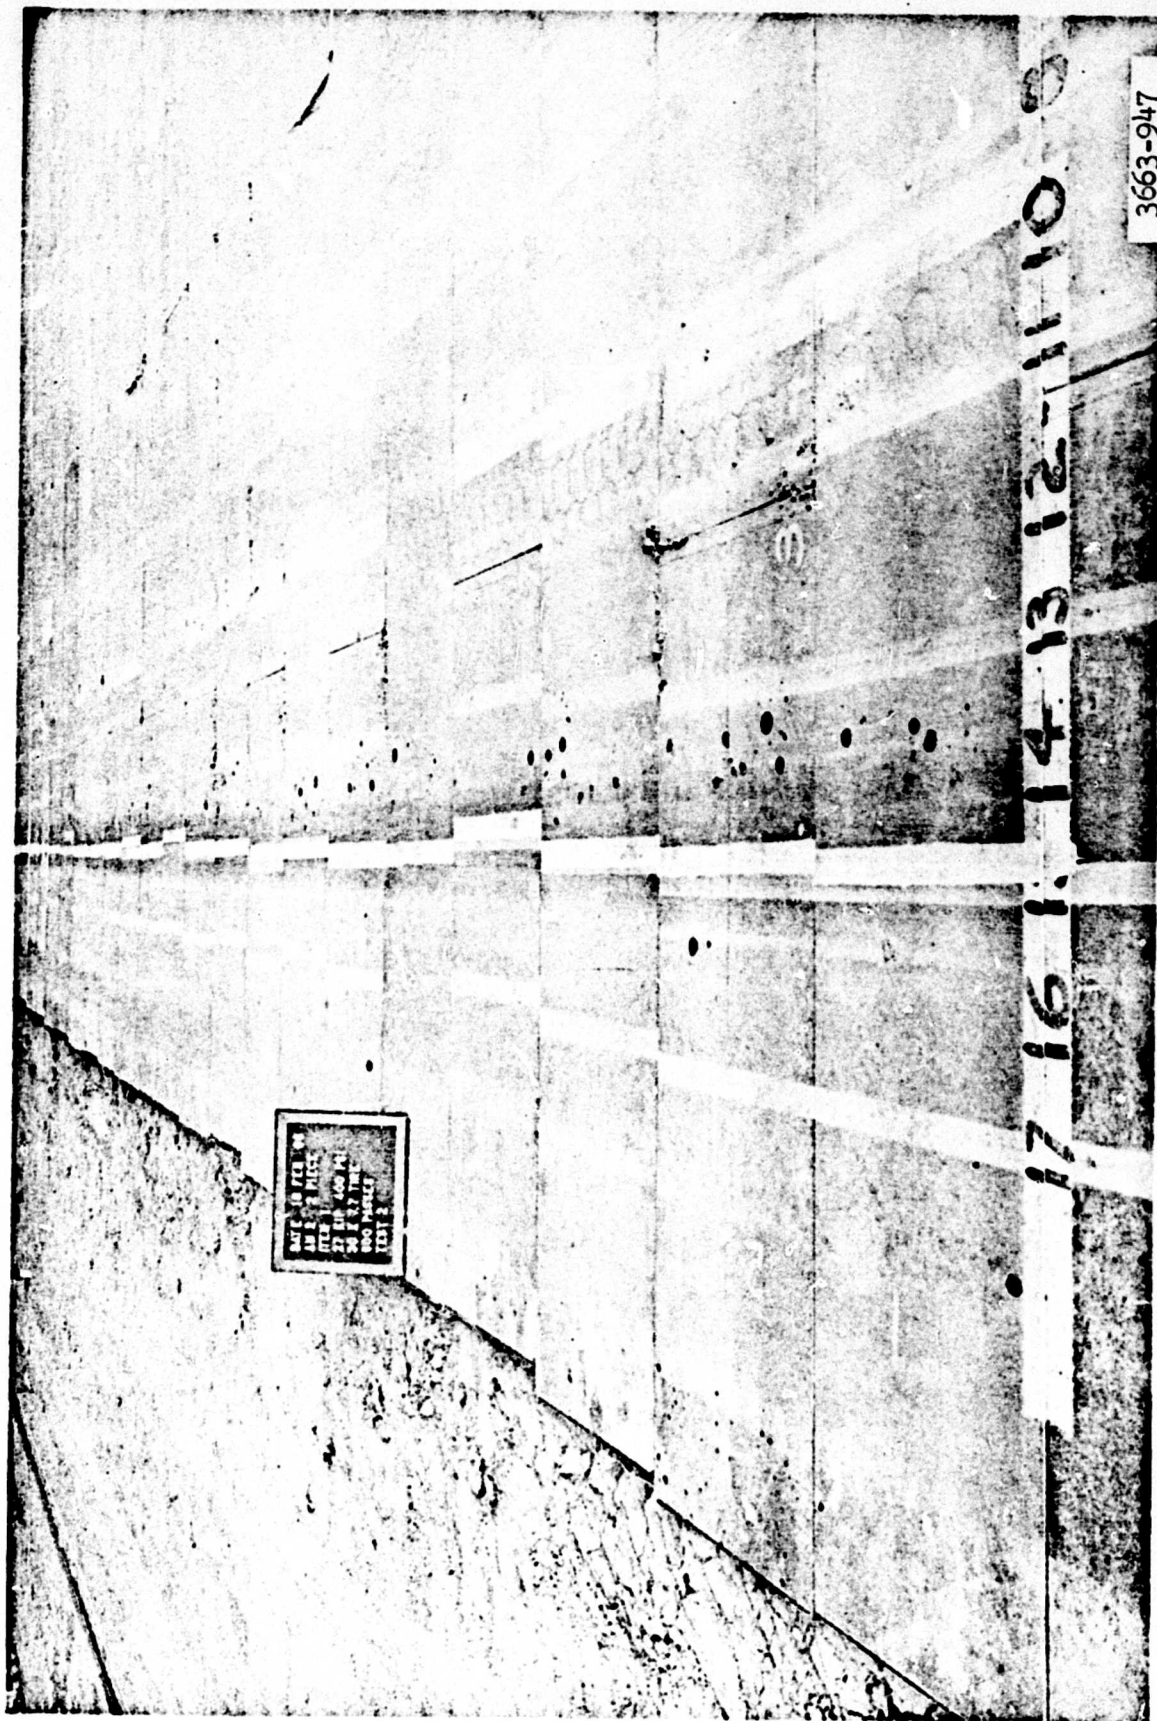
Photograph 8. Lane 2, item 1, after 600 passes

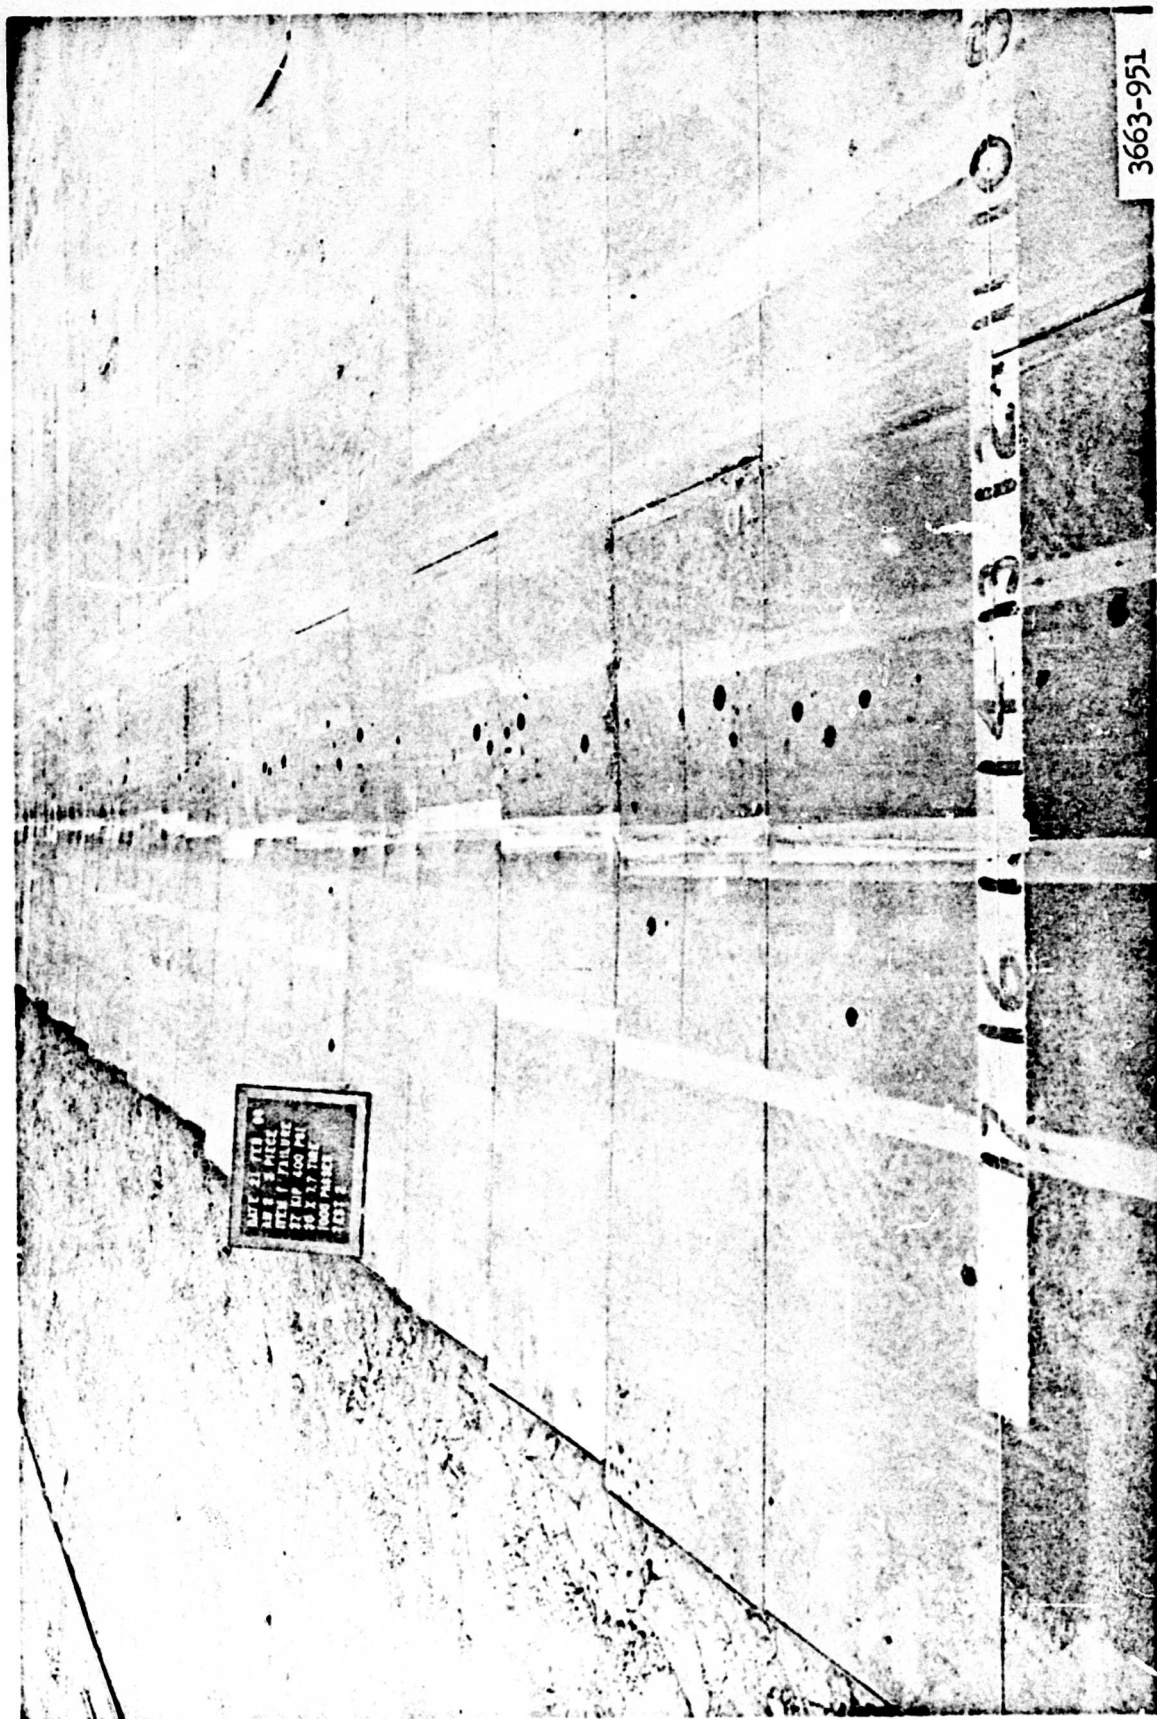
**Photograph 9. Lane 2, item 1, at failure after 100 passes**

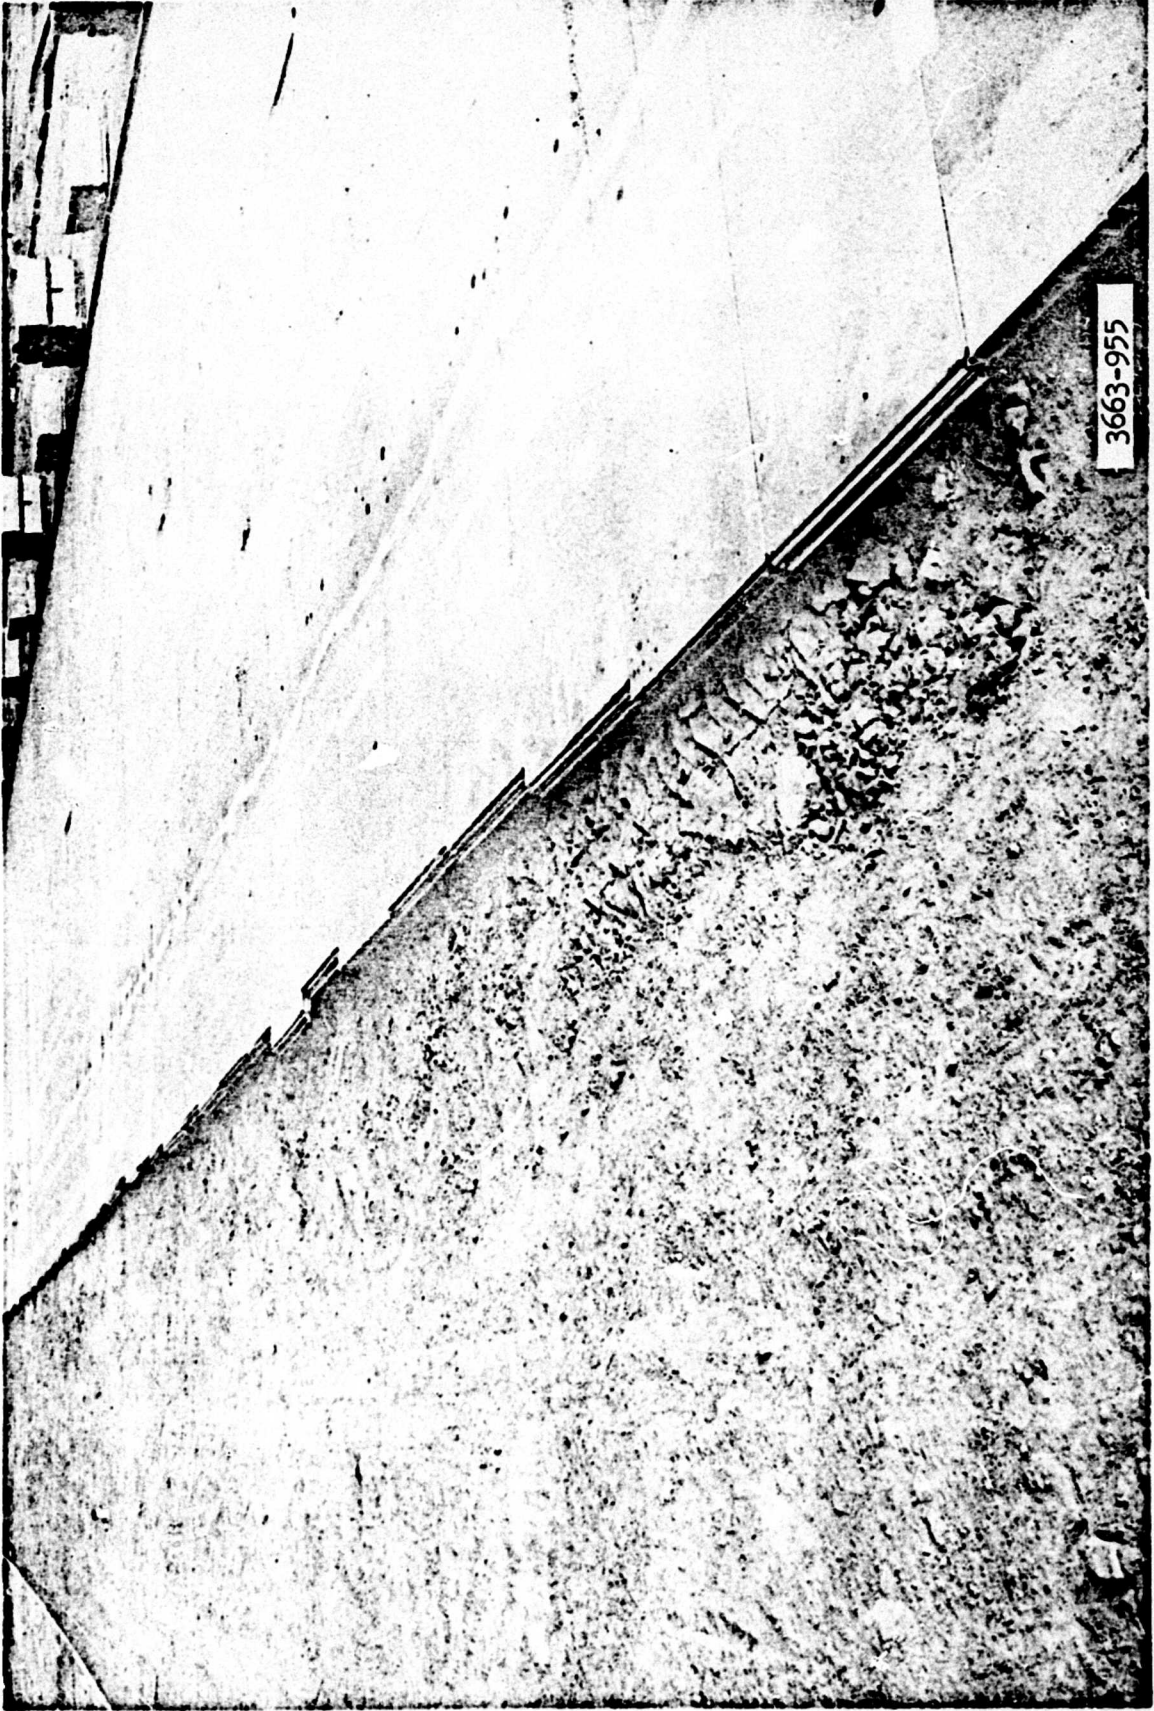
29. Visual observations. A general view of the single-line traffic lane prior to traffic is shown in photograph 7. Severe flexing of the mat on items 1 and 4 was noted from the beginning of traffic. The first mat distress noted occurred at 310 passes when the longitudinal weld of a plank in item 1 developed a crack across the width of the traffic lane. Core damage was first noted in a plank of item 1 after 600 passes. During traffic, horizontal shifting of the mat developed (photograph 8); the shifting was greatest on items 1 and 4, which required realignment at various intervals during traffic. Also visible in photograph 8 is a longitudinal weld in plank 3 which cracked after 310 passes. By 600 passes, longitudinal weld cracks had developed in three mat planks, and indications of core damage were evident in one plank. By 1000 passes, the mat surface in item 1 was very rough and core failure had developed in seven mat planks, at which time the item was considered failed. At failure, the mat surface had rutted and deformed in the traffic path (photograph 9). This deformation caused the east edge of the mat to project up approximately 3 in. off the subgrade (photograph 10).

Photograph 10. Lane 2, item 1, after 1000 passes. Note bending of mat causing edges of planks to project upwards

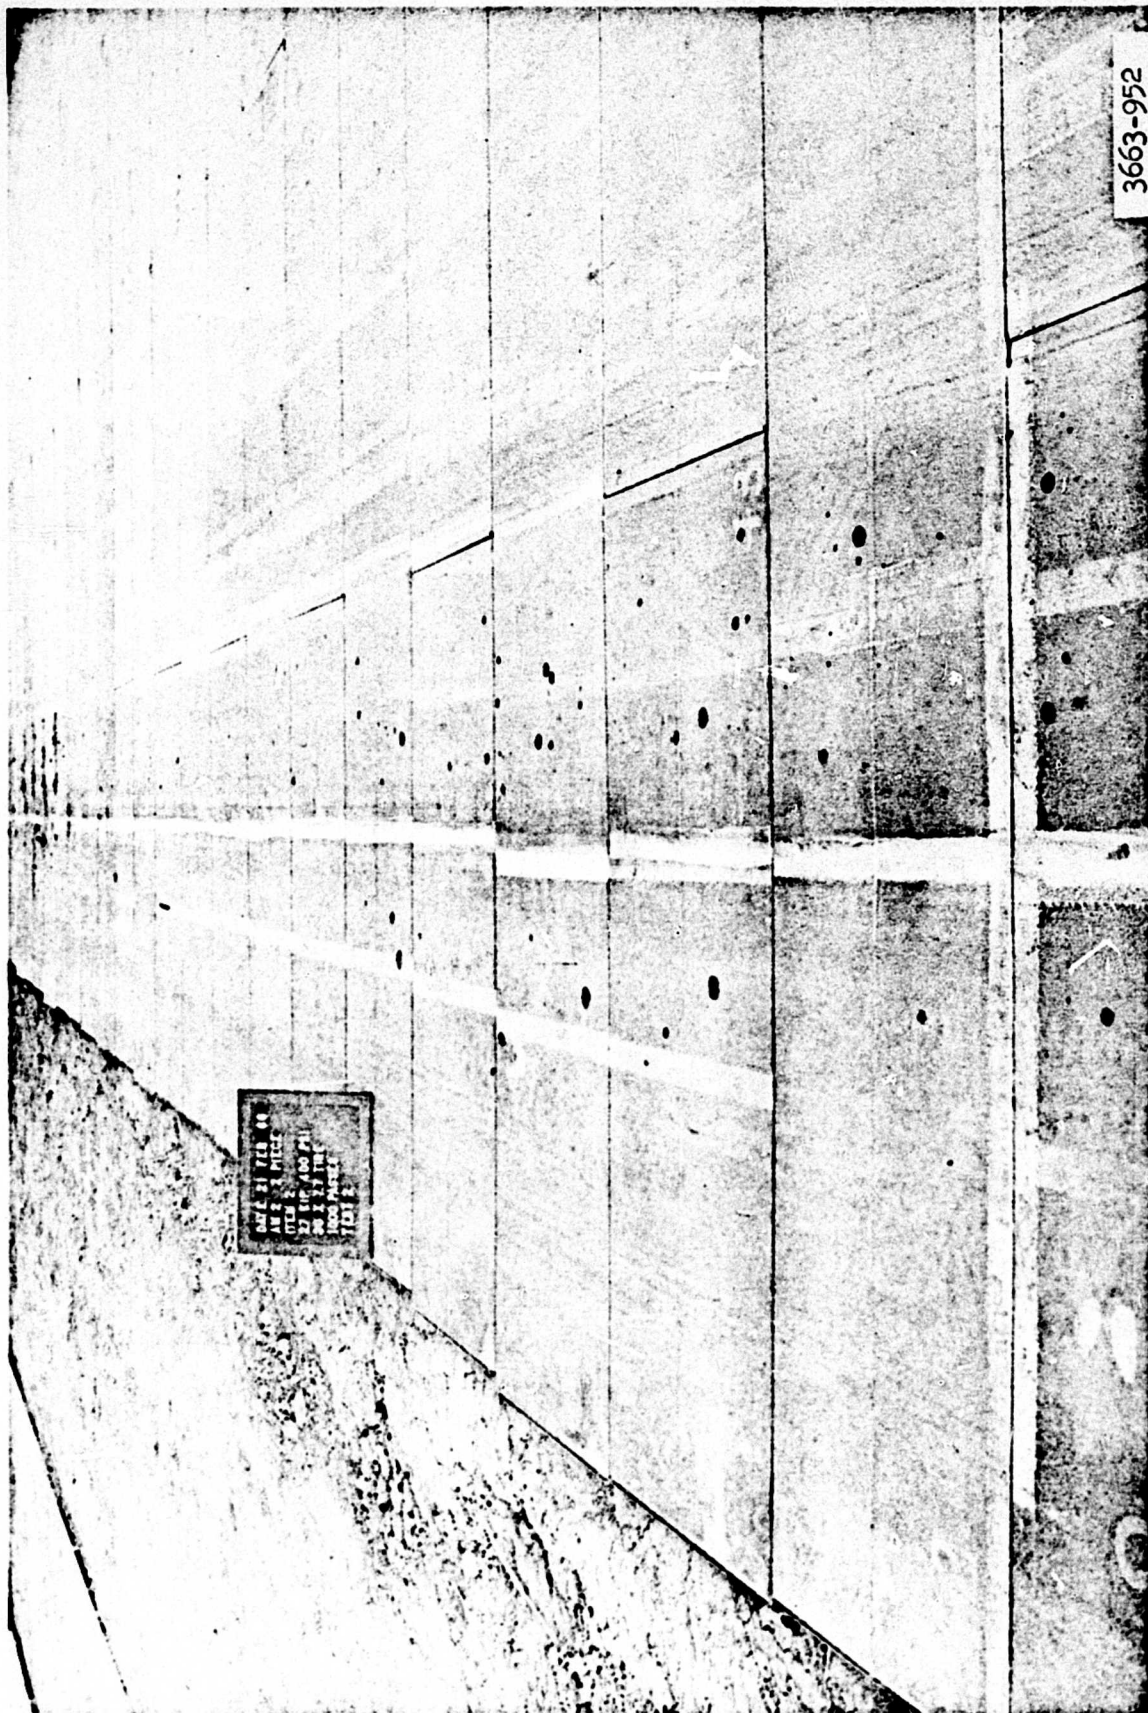
30. Some mat distress was noted in test items 2 and 4 at the end of 1000 passes, but little or no distress was noted in test item 3. Views of items 2, 3, and 4 at the end of 1000 passes of the load wheel are shown in photographs 11, 12, and 13, respectively. As traffic was continued, rapid deterioration of the mat in items 2 and 4 developed between 1200 and 1600 passes, and these items were considered failed after 1600 passes of traffic. The mat in item 3 was still in good condition when traffic was terminated. Test items 2, 3, and 4 at the end of traffic (1600 passes) are shown in photographs 14, 15, and 16, respectively. A typical longitudinal weld crack and dished planks indicating core failure are shown in fig. 5. One plank from each of the items was cut on the traffic lane center line. A cross-section view of each of these is shown in fig. 6. In the figure, planks 1, 2, 3, and 4 are from items 1, 2, 3, and 4, respectively, and are representative of the comparative damage suffered by each item by the end of traffic. It can be seen that the bottom weld had cracked in planks 2 and 4, whereas the top was still in good

Photograph 11. Lane 2, item 2, after 1000 passes

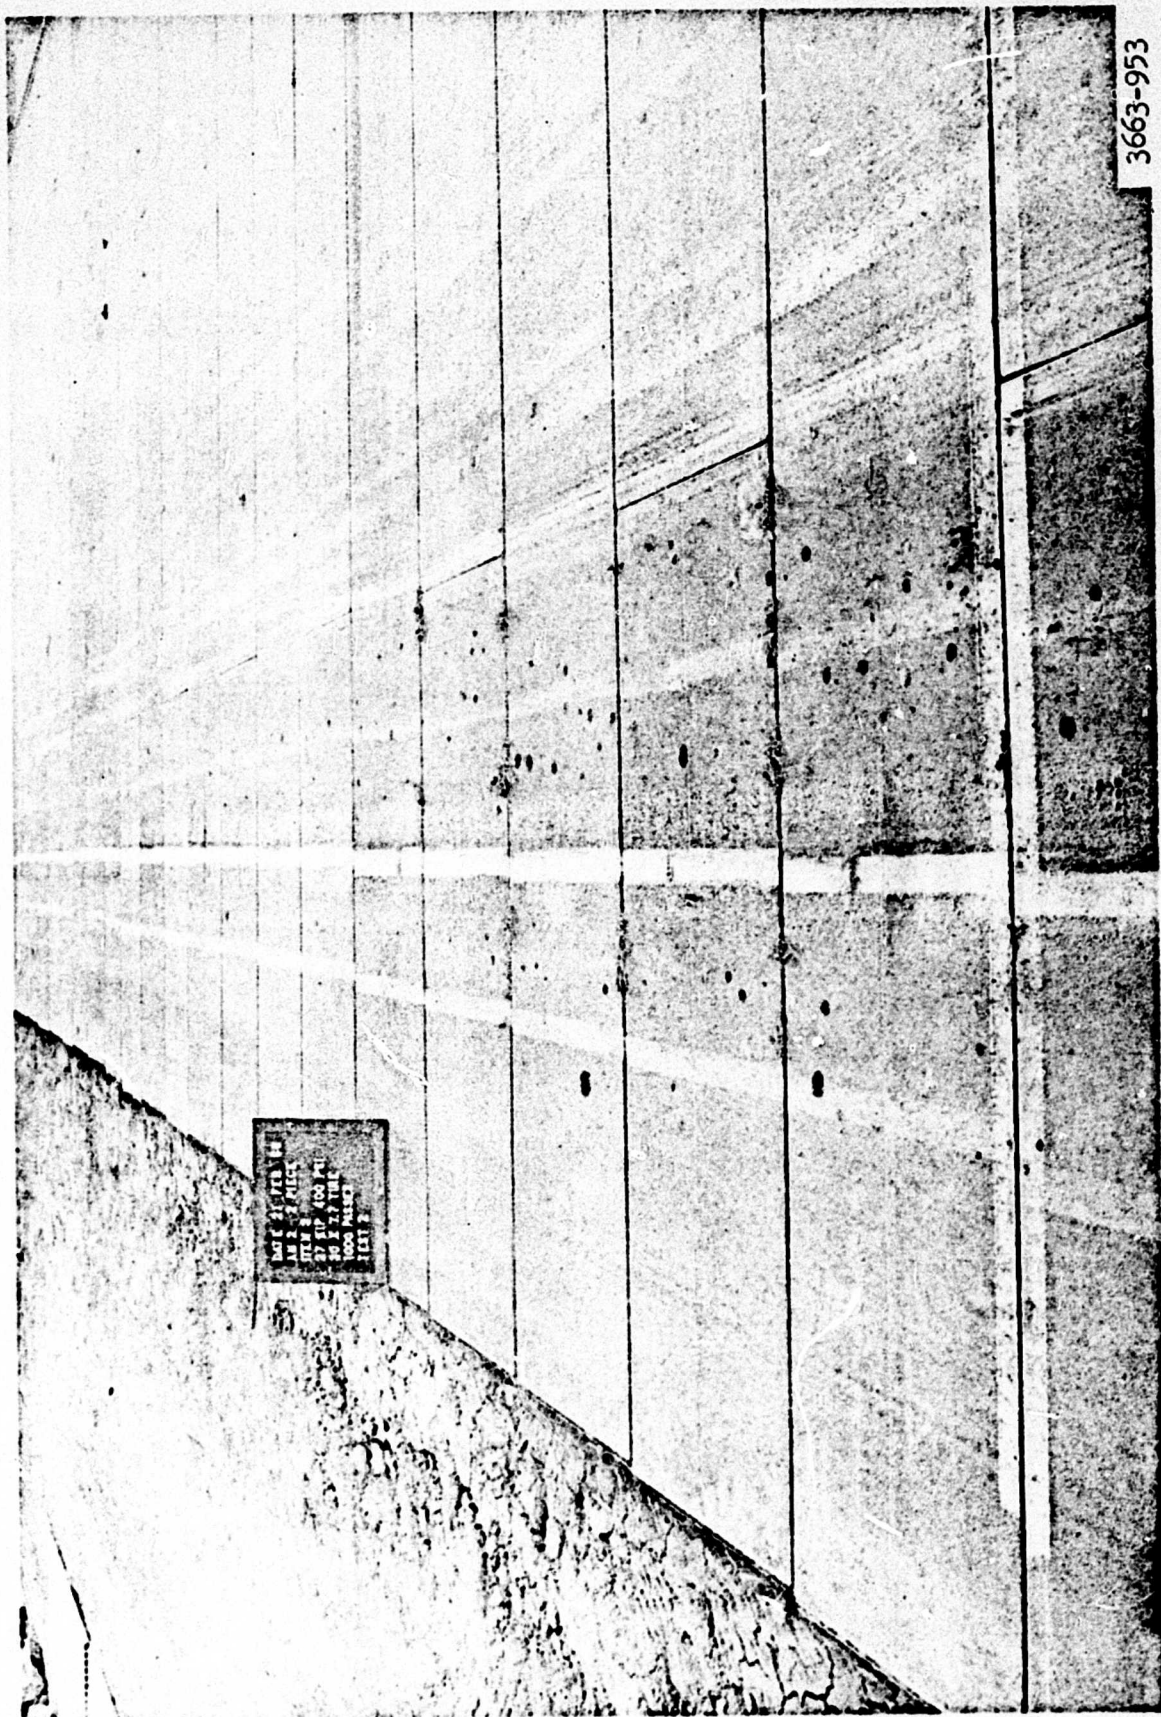
Photograph 12. Lane 2, item 3, after 1000 passes

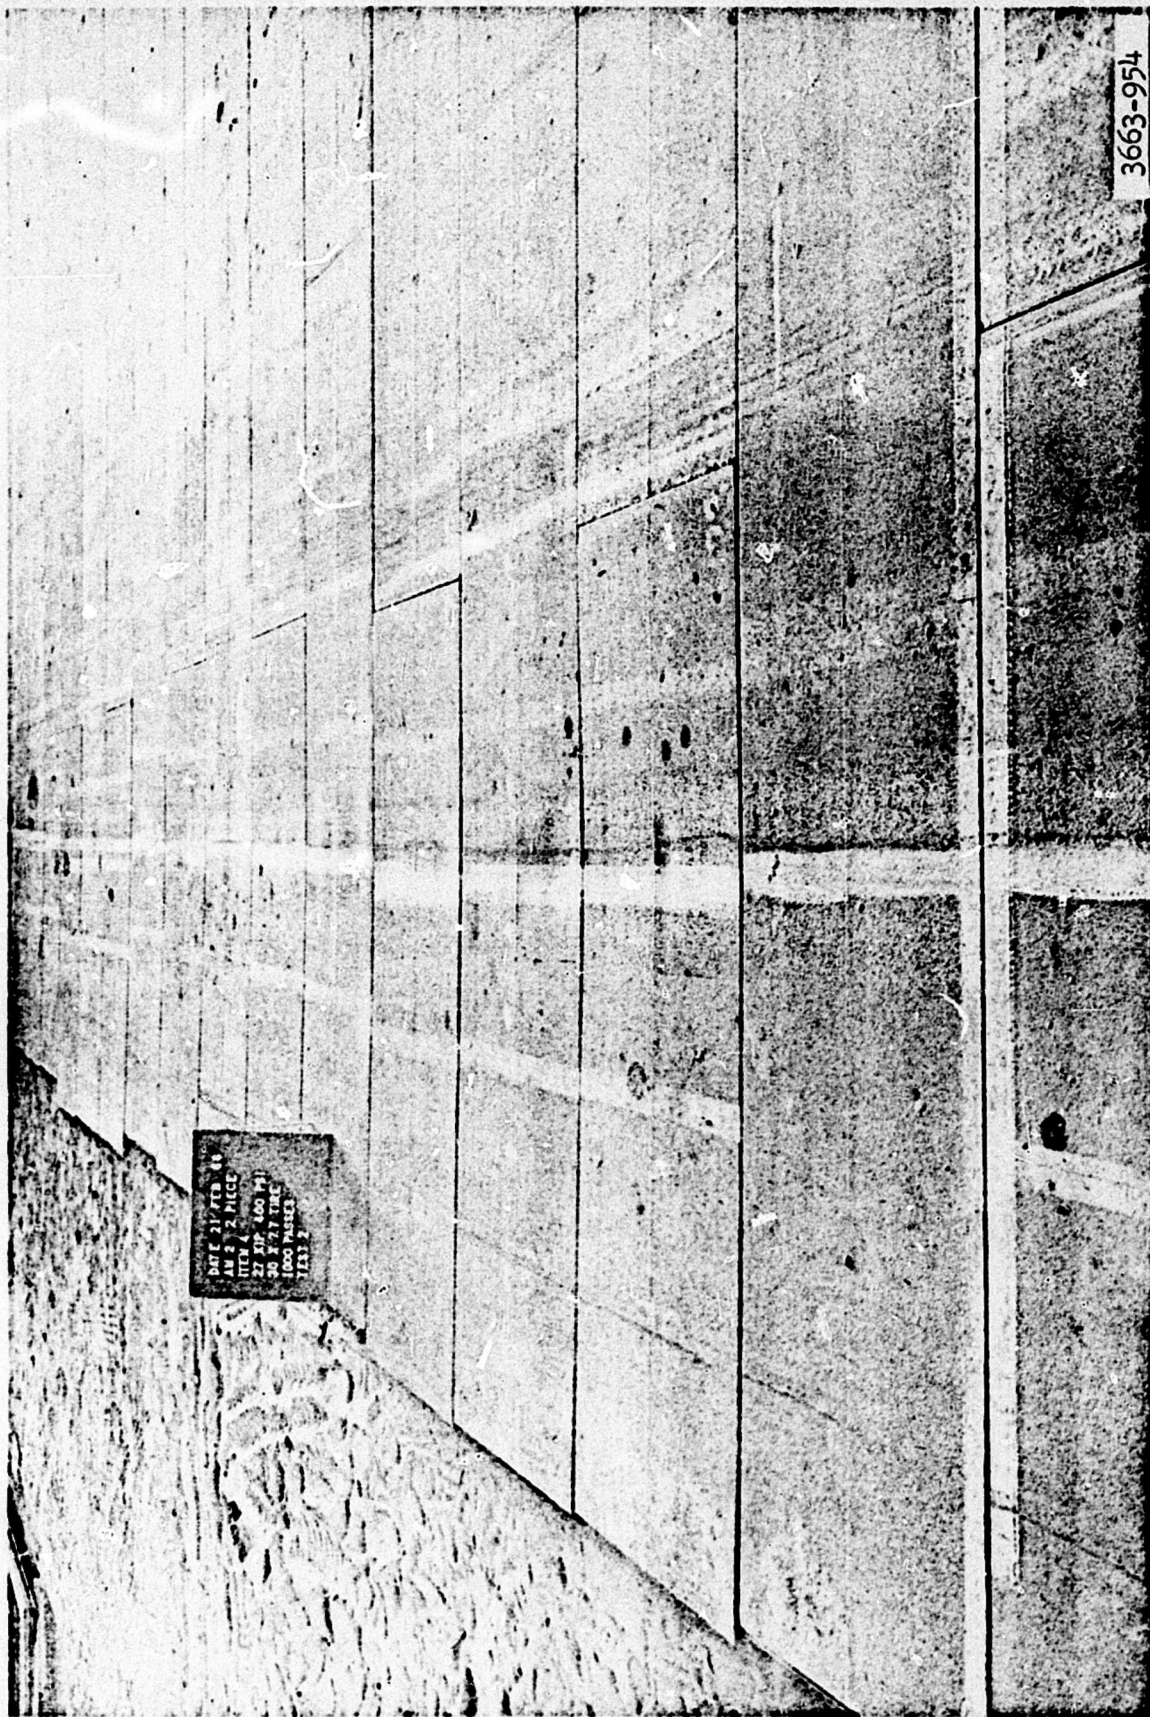
Photograph 13. Lane 2, item 4, after 1000 passes

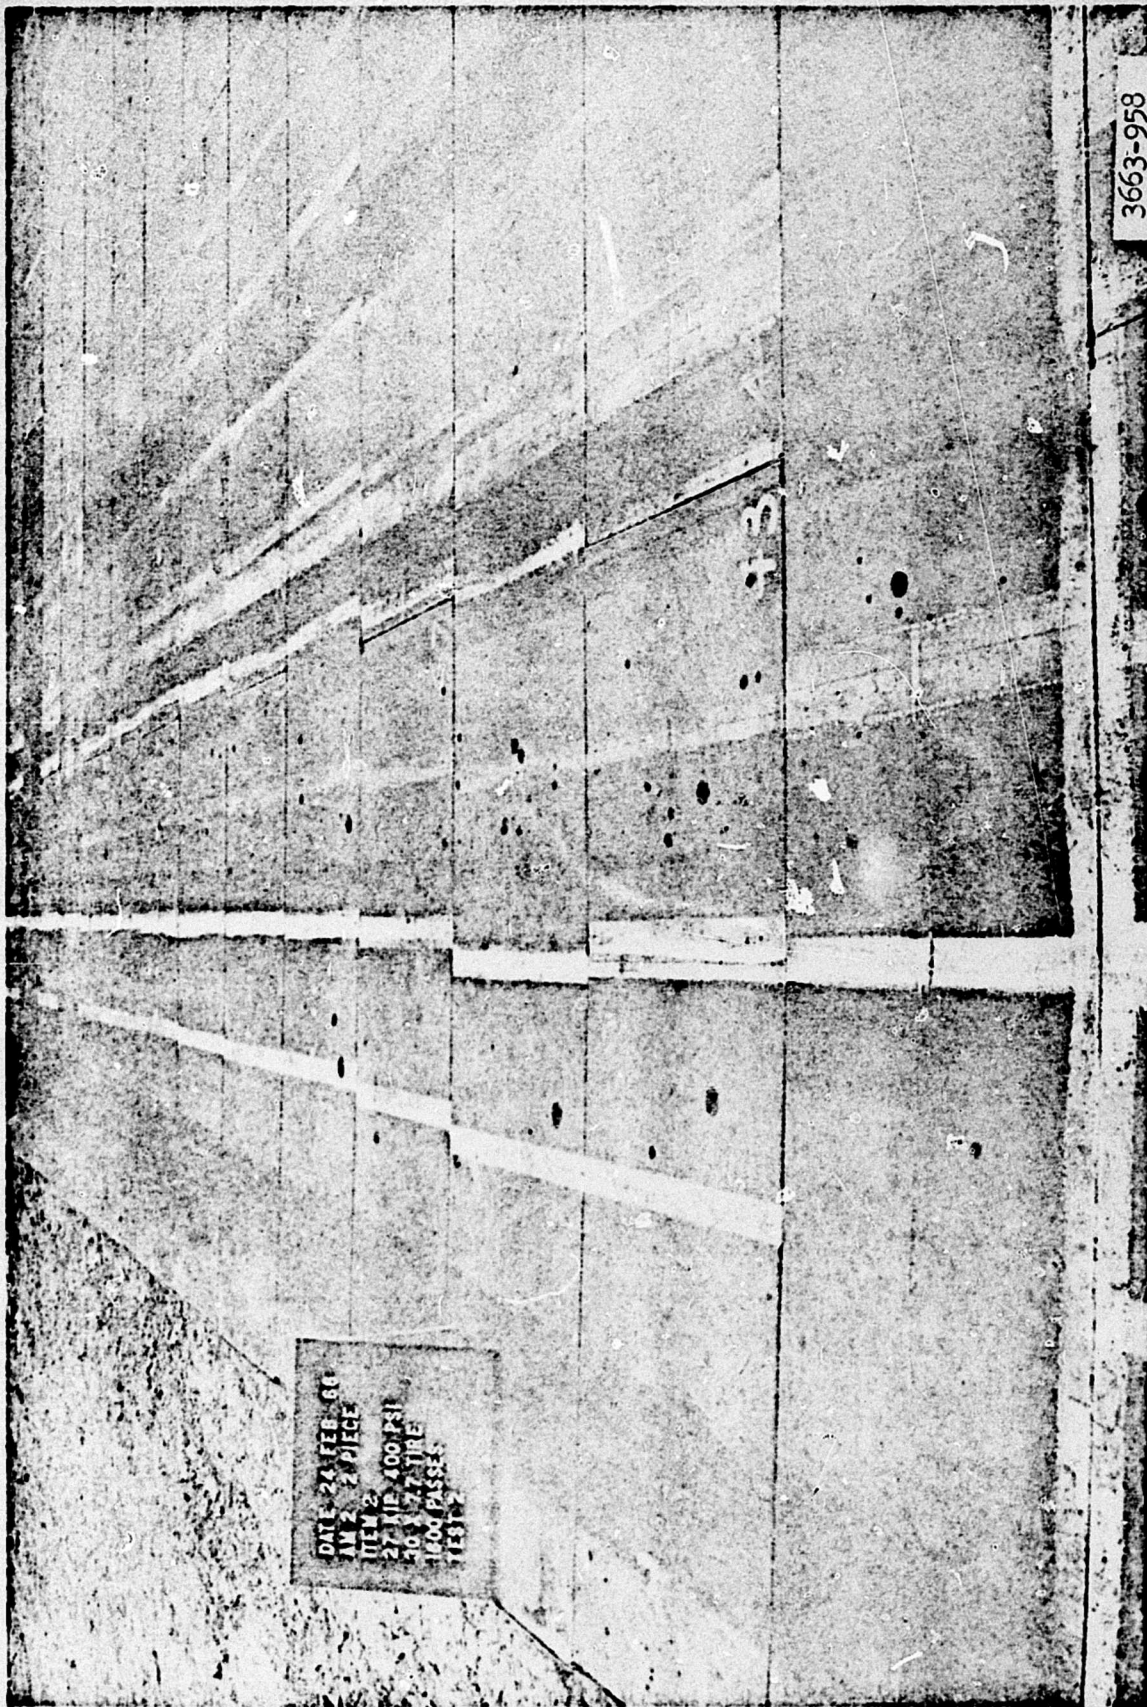
Photograph 14. Lane 2, item 2, at failure after 1600 passes
